Manhole Inspection Summary

Manhole # S2500_001MH

Insp Date: **7/26/07 10:31 AM**

Location Address: **2510 BROOKFIELD AVE**

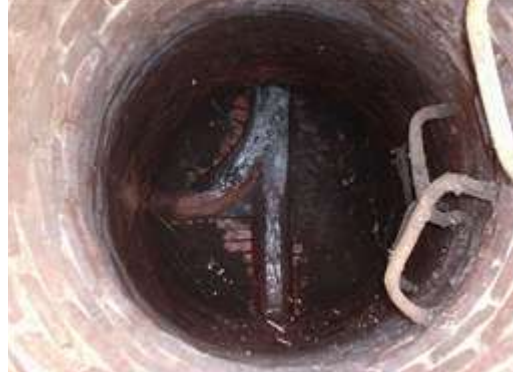
Top View

Corroded steps. Evidence of surcharge - Bench debris.

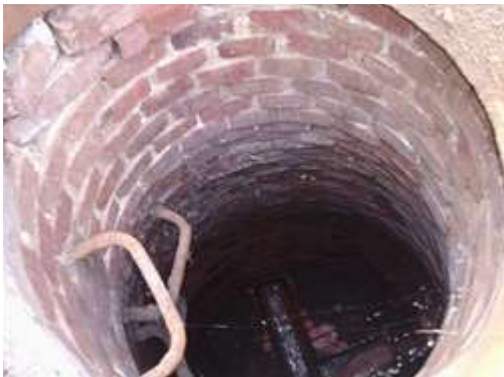
Defect

Frame leaks. Adjustment deterioration and infiltration. Corbel and Barrel infiltration - other side.

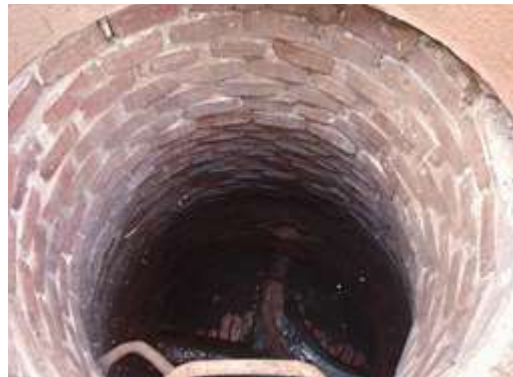
Defect

Frame leaks. Adjustment deterioration and infiltration. Corbel and Barrel infiltration.

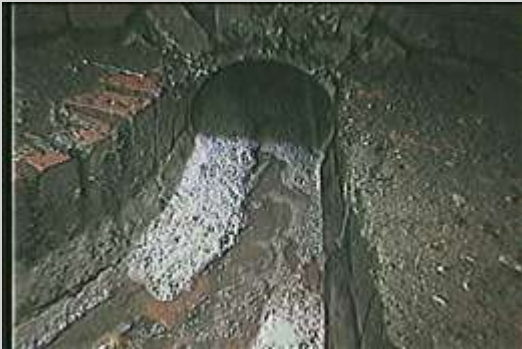
8 in. Circular Gravity Sewer Pipe Out @ 12 O'Clock

Channel deterioration.

Infiltration: **None** Pipe Seal Cond: **Cracked**

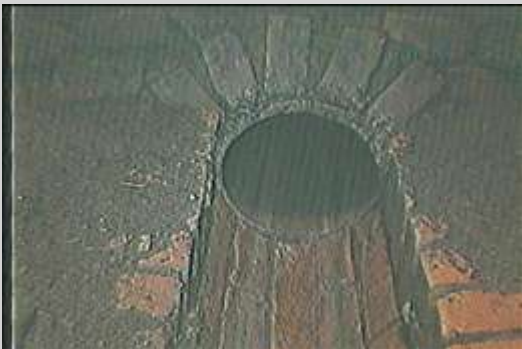
8 in. Circular Gravity Sewer Pipe In @ 6 O'Clock

Infiltration: **Evidence** Pipe Seal Cond: **Cracked**

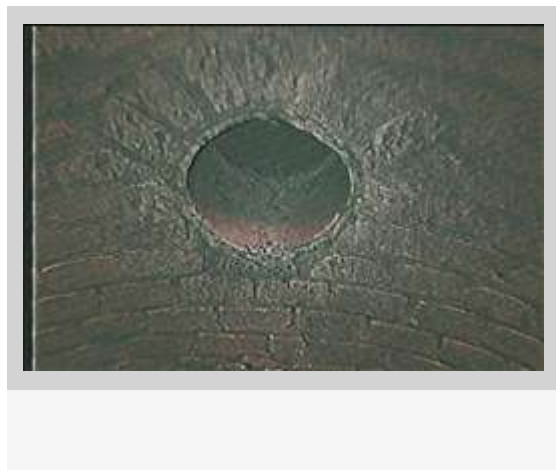
Pipe In @ 9 O'Clock

Infiltration: **Evidence** Pipe Seal Cond: **Unknown**

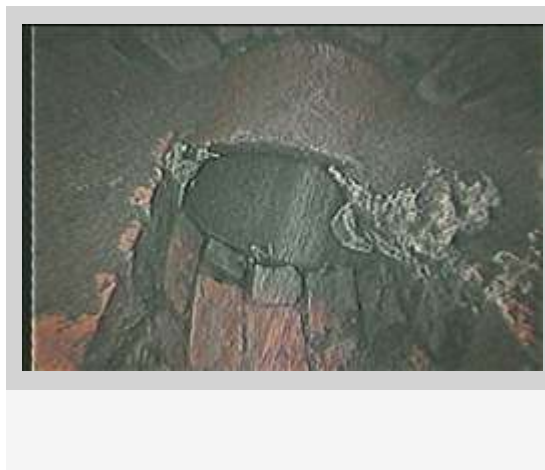
Drop In @ 9 O'Clock

Drop: Outside	Rod and Bar
Angled: Yes	Reading: 9.40 (ft.)
	Inv Depth: 10.40 (ft.)
Drop Condition: Open
